Evaluation of arctic ice-free land sites
Kronprins Christian Land and Peary Land,
North Greenland 1960

William E. Davies
Daniel B. Krinsley

Air Force Surveys in Geophysics
No. 135

Project 7628
Task 76284

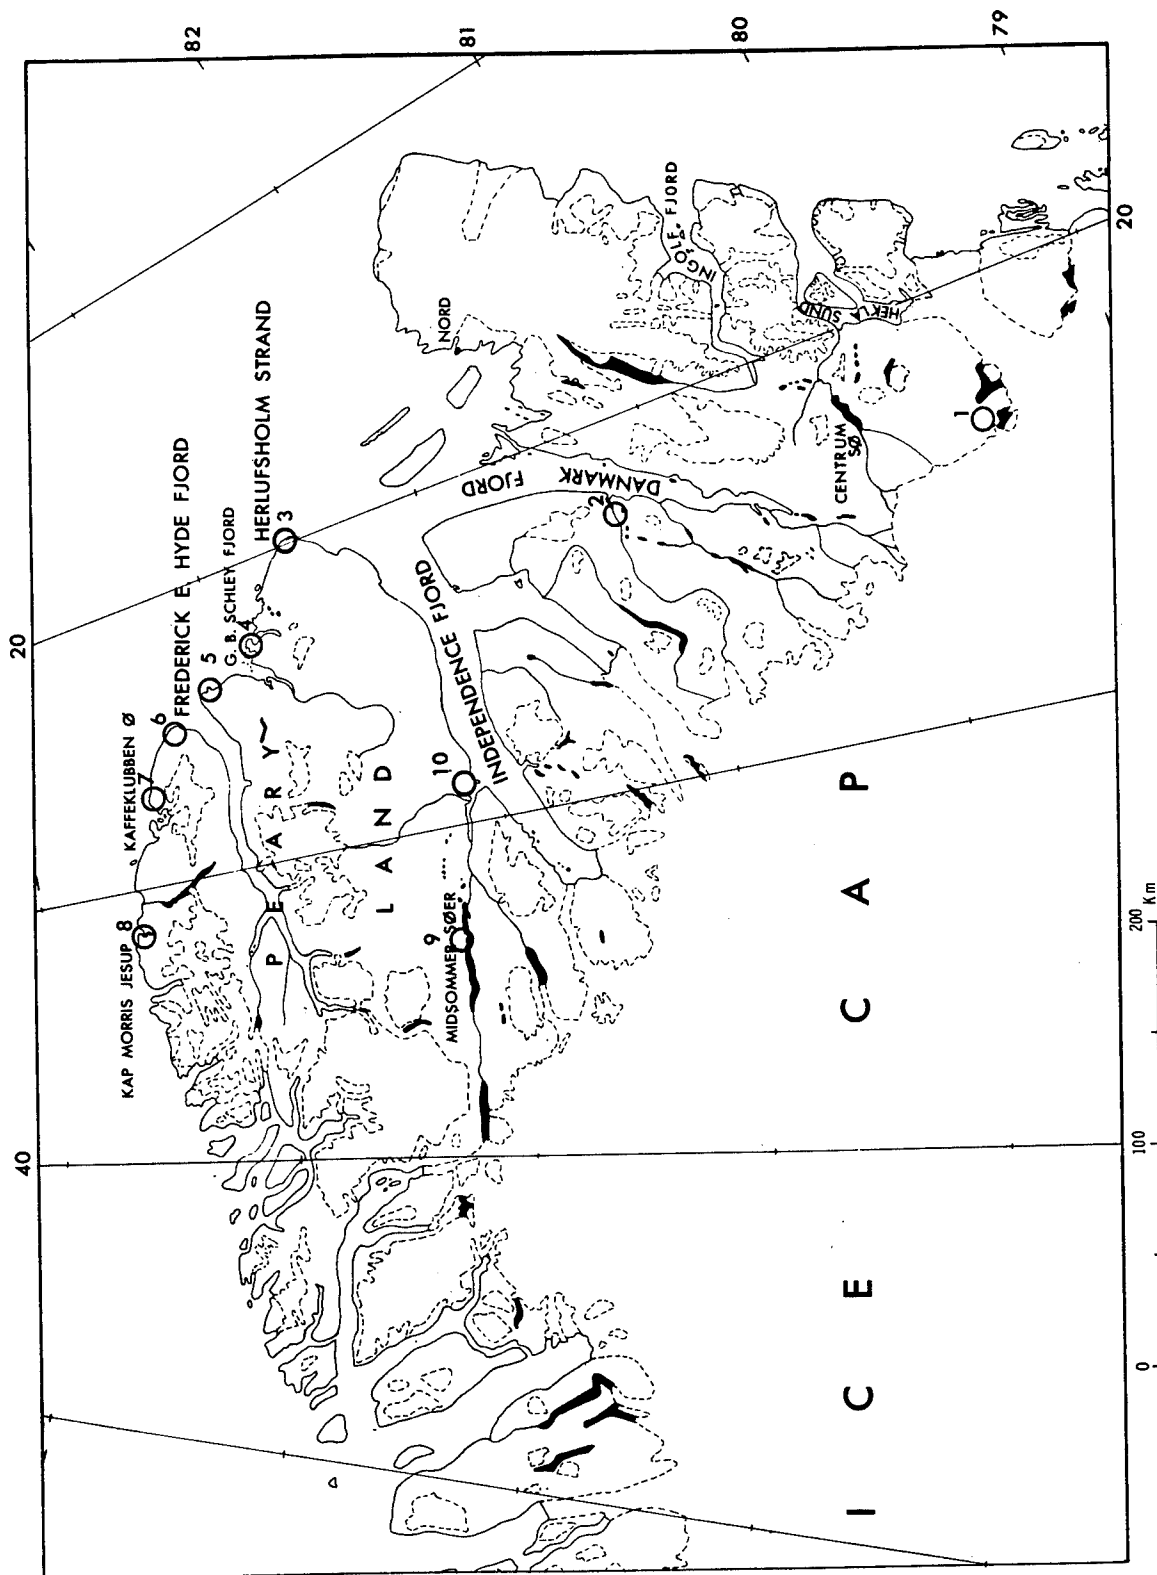
Figure 1. North Greenland. Sites studied are shown by circle and number. 1) Blaasø, 2) Kap Renaissance, 3) Herlufsholm Strand, 4) Kap Wyckoff, 5) Skagen, 6) Kap Ole Chiewitz, 7) Bliss Bugt, 8) Kap Morris Jesup, 9) Slusen-Midsommersøer, 10) Brønlund Fjord.

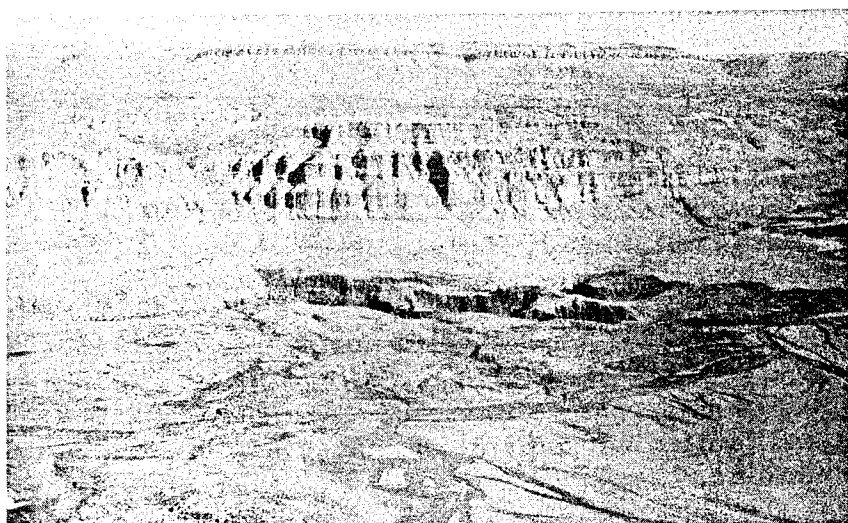
Figure 4. View
north from Kap
Ole Chiewitz
showing the alpine
mountains and
coastal plain on
the north side of
Peary Land,
6 July 1960.

The eastern coastal area consists of alpine mountains as much as 6000 ft (1830 m) in altitude (Fig. 4). The mountains are cut by numerous valley glaciers and the upland is cut into a series of sharp peaks. This mountain belt is 40 to 60 miles (64 to 96 km) wide, extending northwards to near Station Nord.

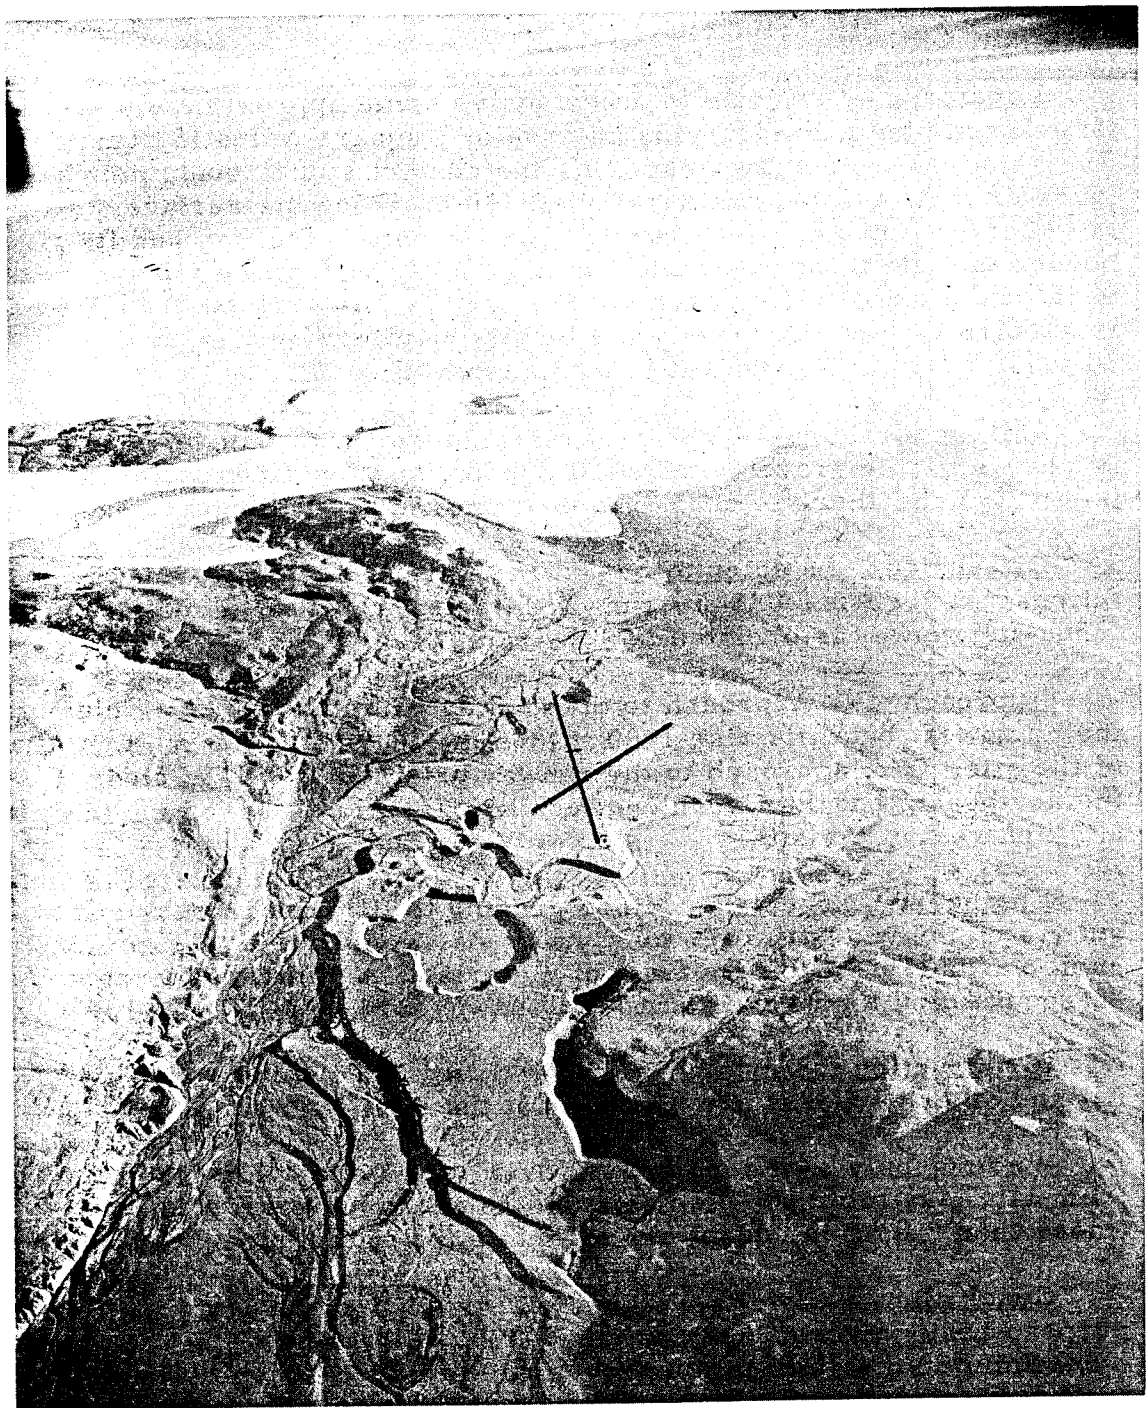
Figure 5. Blaasø site, view west.

Location -- Site is in a broad valley 6 miles (10 km) west of Blaasø.
79° 35'N x 23° 20'W (Fig. 5).

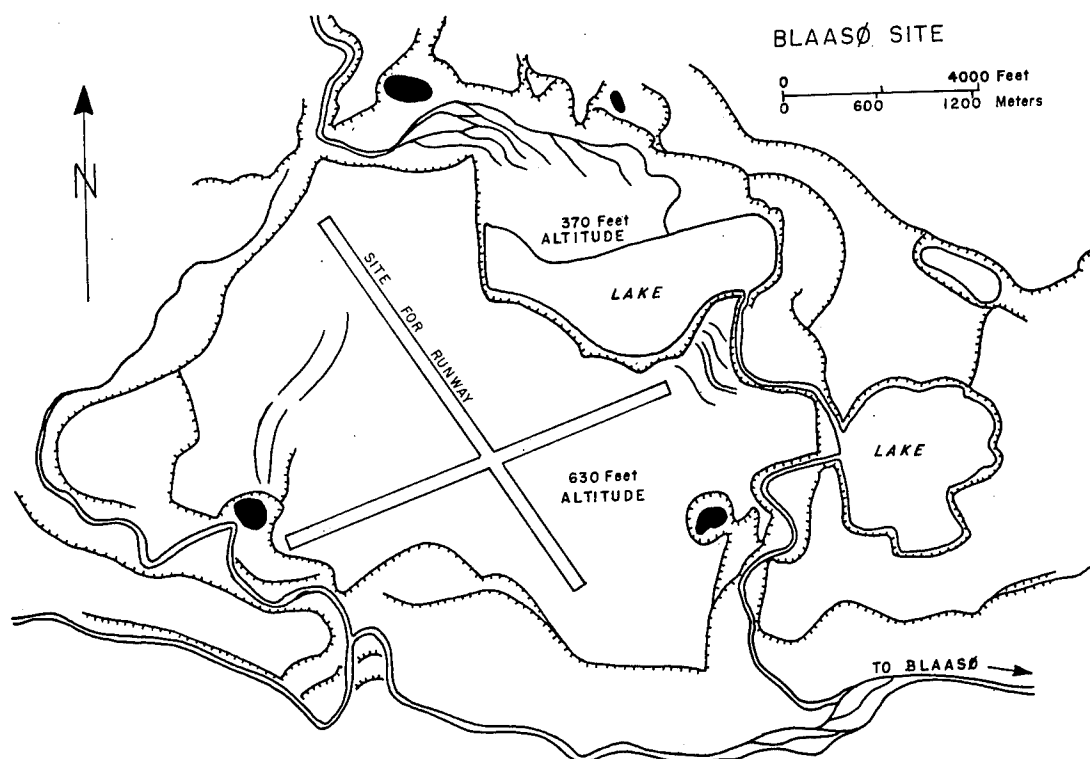
Figure 7. Map of Blaasø site.

Dimensions and orientation -- There are two possible runway orientations. A 9000-ft (2743-m) runway is oriented N33° W, and a 8400-ft (2560-m) runway is oriented N70° E (Fig. 7).

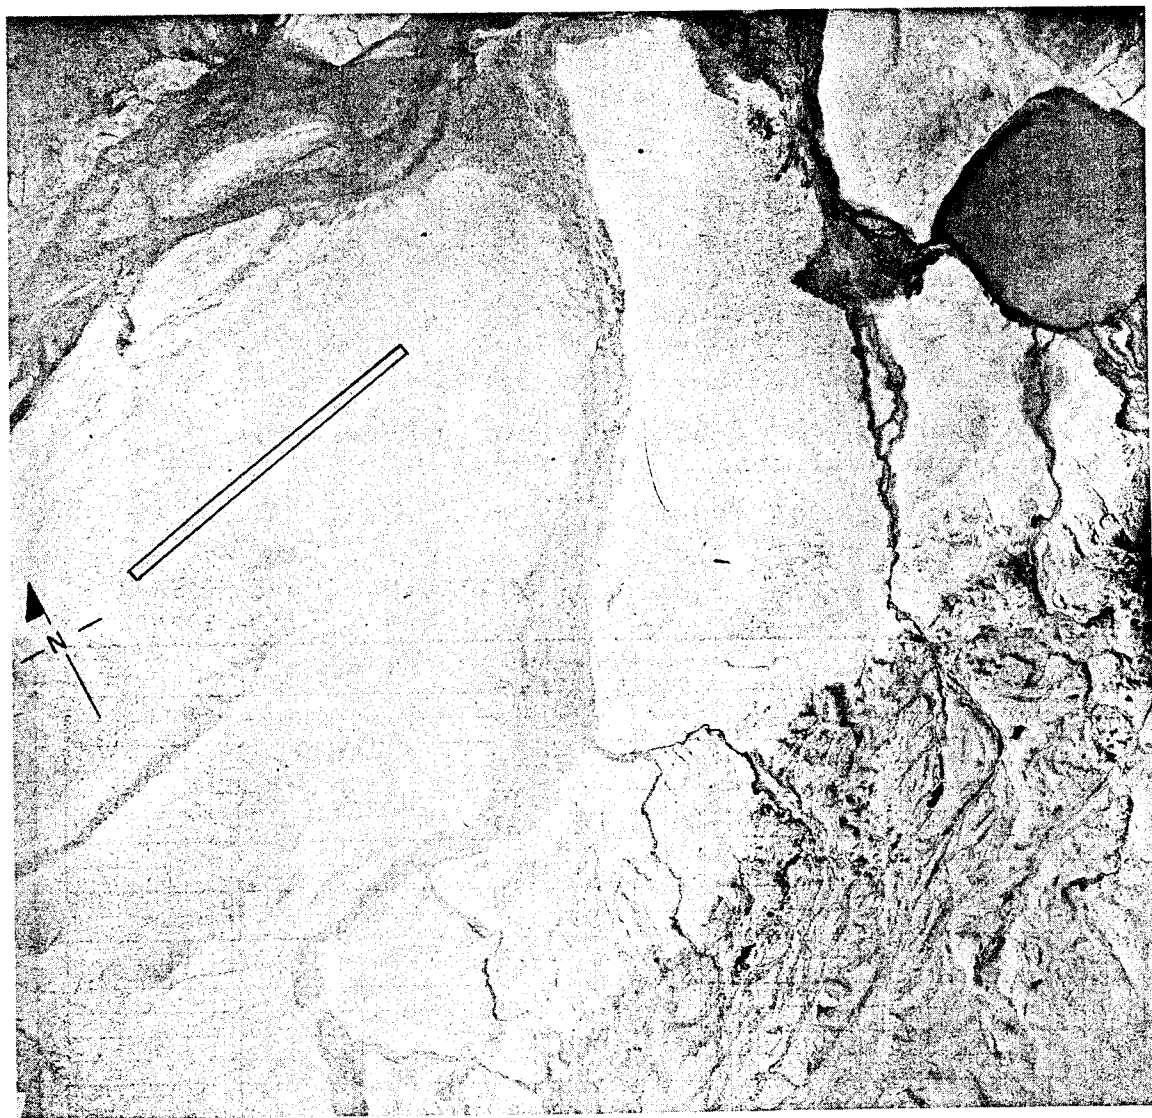
Figure 8. Kap Renaissance site.

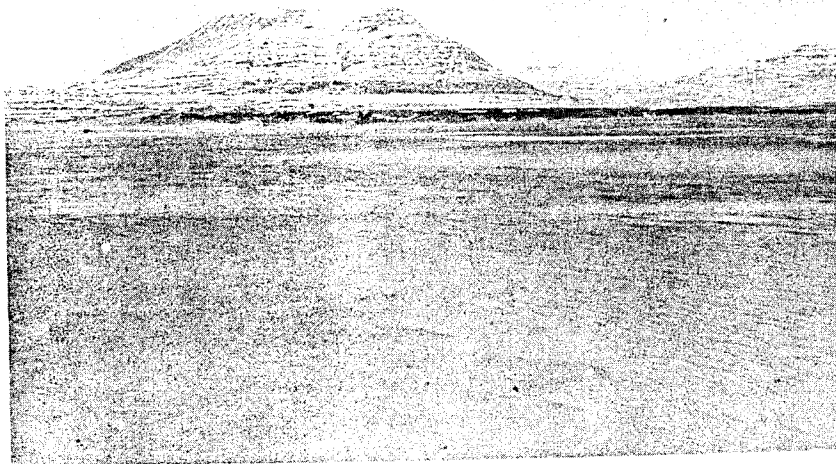
Figure 9. Kap Renaissance site, view west over Sjaellandssletten. 2 July 1960.

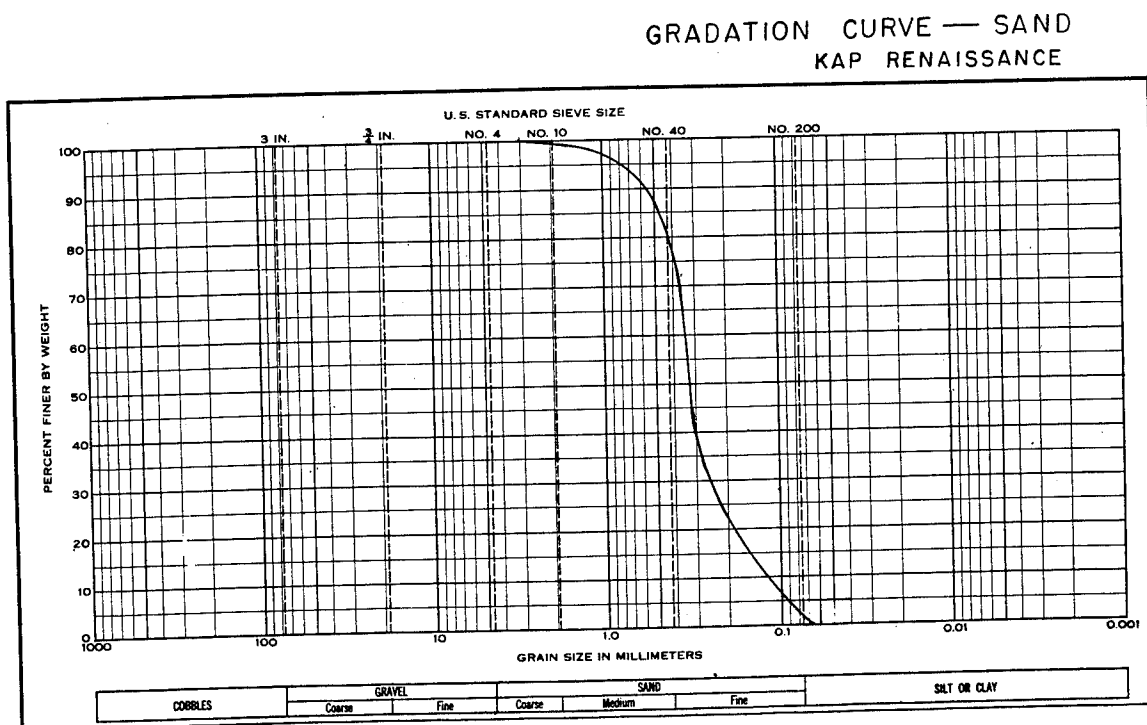
Soil and drainage -- The surface soil is a well-drained, poorly graded, coarse sand (Fig. 10). The upper 6 inches (15 cm) is dry and loose; below this it is damp but weak. At 20 inches (50 cm) the CBR is less than 3. The sand is about 3 to 8 ft (1 to 2 m) thick resting on clay-silt which is exposed in valleys and flats bordering the sand area.

Figure 10. Kap Renaissance site, gradation curve, sand.

Engineering aspects -- The site would require no grading. Stabilization and strengthening of the sand surface would be necessary to prevent excessive rutting. In addition, stabilization is necessary to control

drifting sand which is common at the site. Silty clay for use as a binder is abundant adjacent to the sand flat.

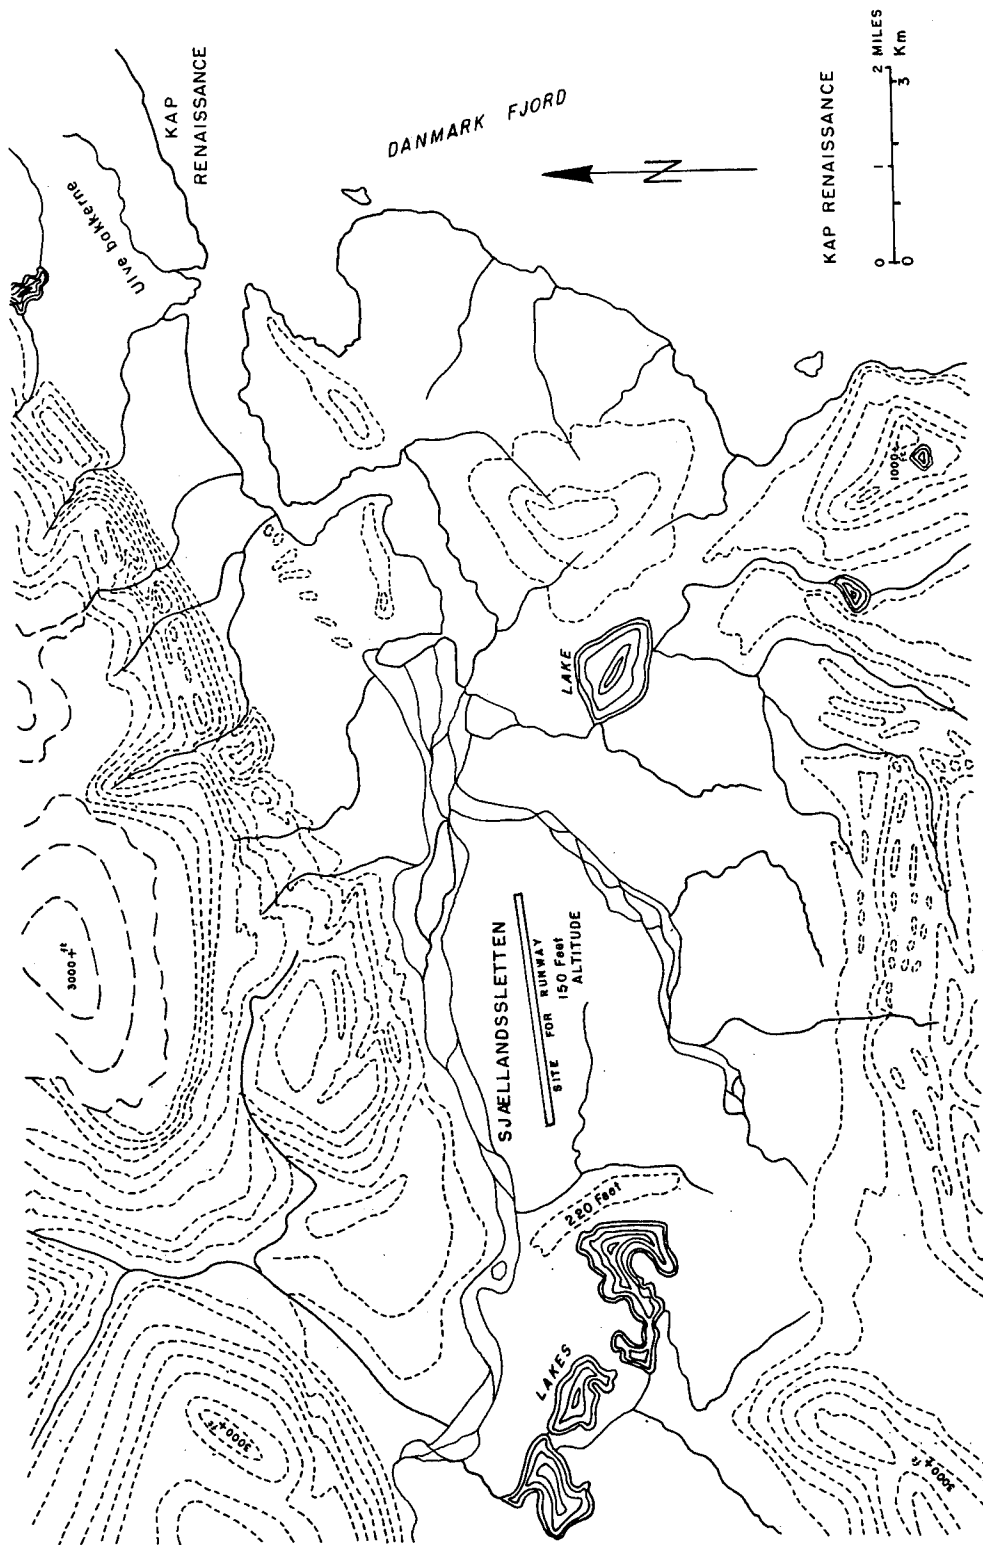
Figure 11. Map of Kap Renaissance site.

Dimensions and orientation -- The best orientation for a runway is east-west. A length of 12,750 ft (3900 m) with minimum width of 600 ft (182 m) can be utilized without grading (Fig. 11).

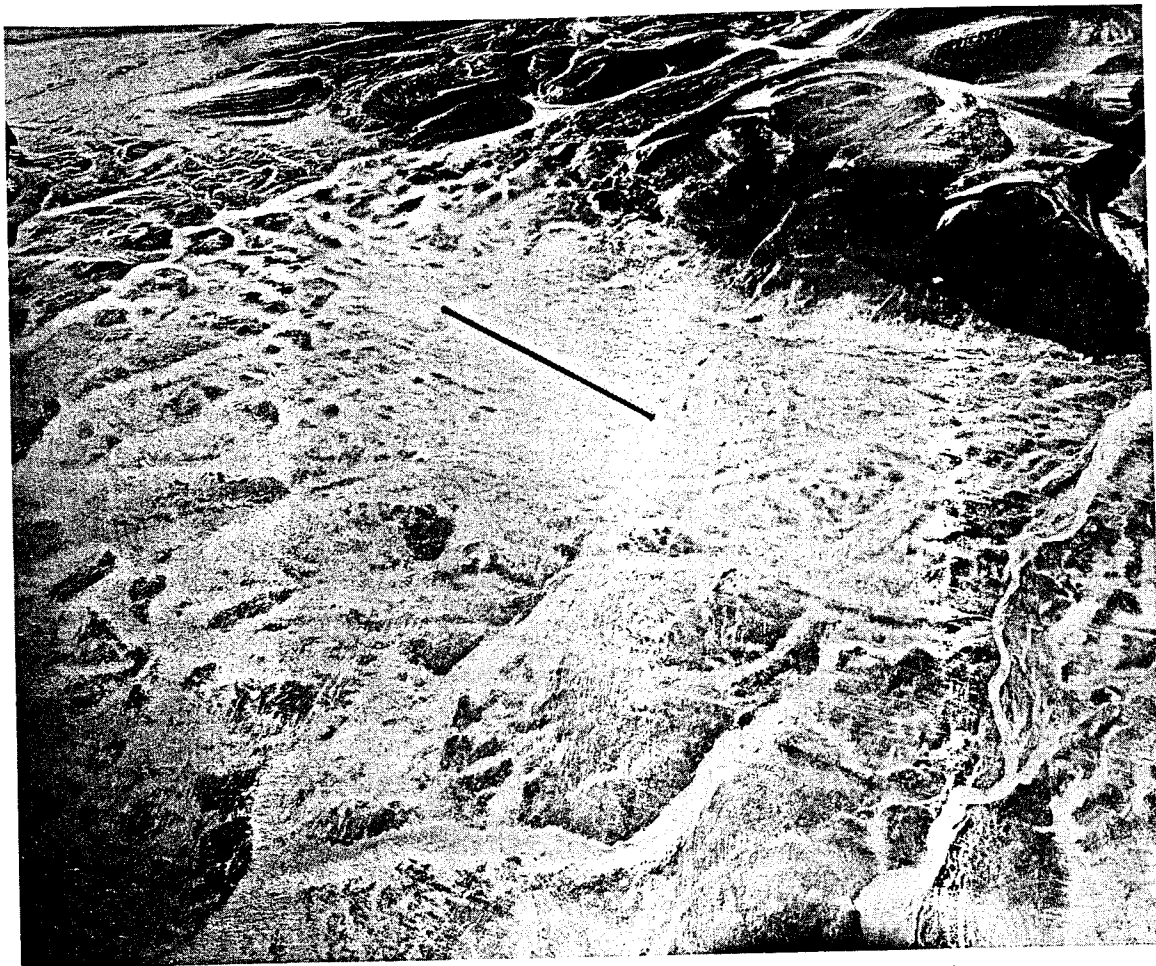
Location -- There are two sites, one 8 miles (13 km) northwest of Kap Eiler Rasmussen, the second on the coast 4 miles (6 km) north of Kap Eiler Rasmussen at Kølnaes (Figs. 12 and 13).

Landform -- The sites are on a coastal plain 6 to 8 miles (10 to 13 km) wide that extends 20 miles (32 km) northeast from Independence Fjord. The plain slopes gently from the Arctic Ocean southwards to the foot of the mountains where it is about 300 ft (91 m) high. Prominent terraces and moraines as much as 330 ft (100 m) in altitude occur over most of the strand. The site near Kølnaes is on a beach about 3 ft (1 m) above sea level. The other site is on a terrace at the base of the mountains.

Figure 12. Herlufsholm Strand sites, view west.

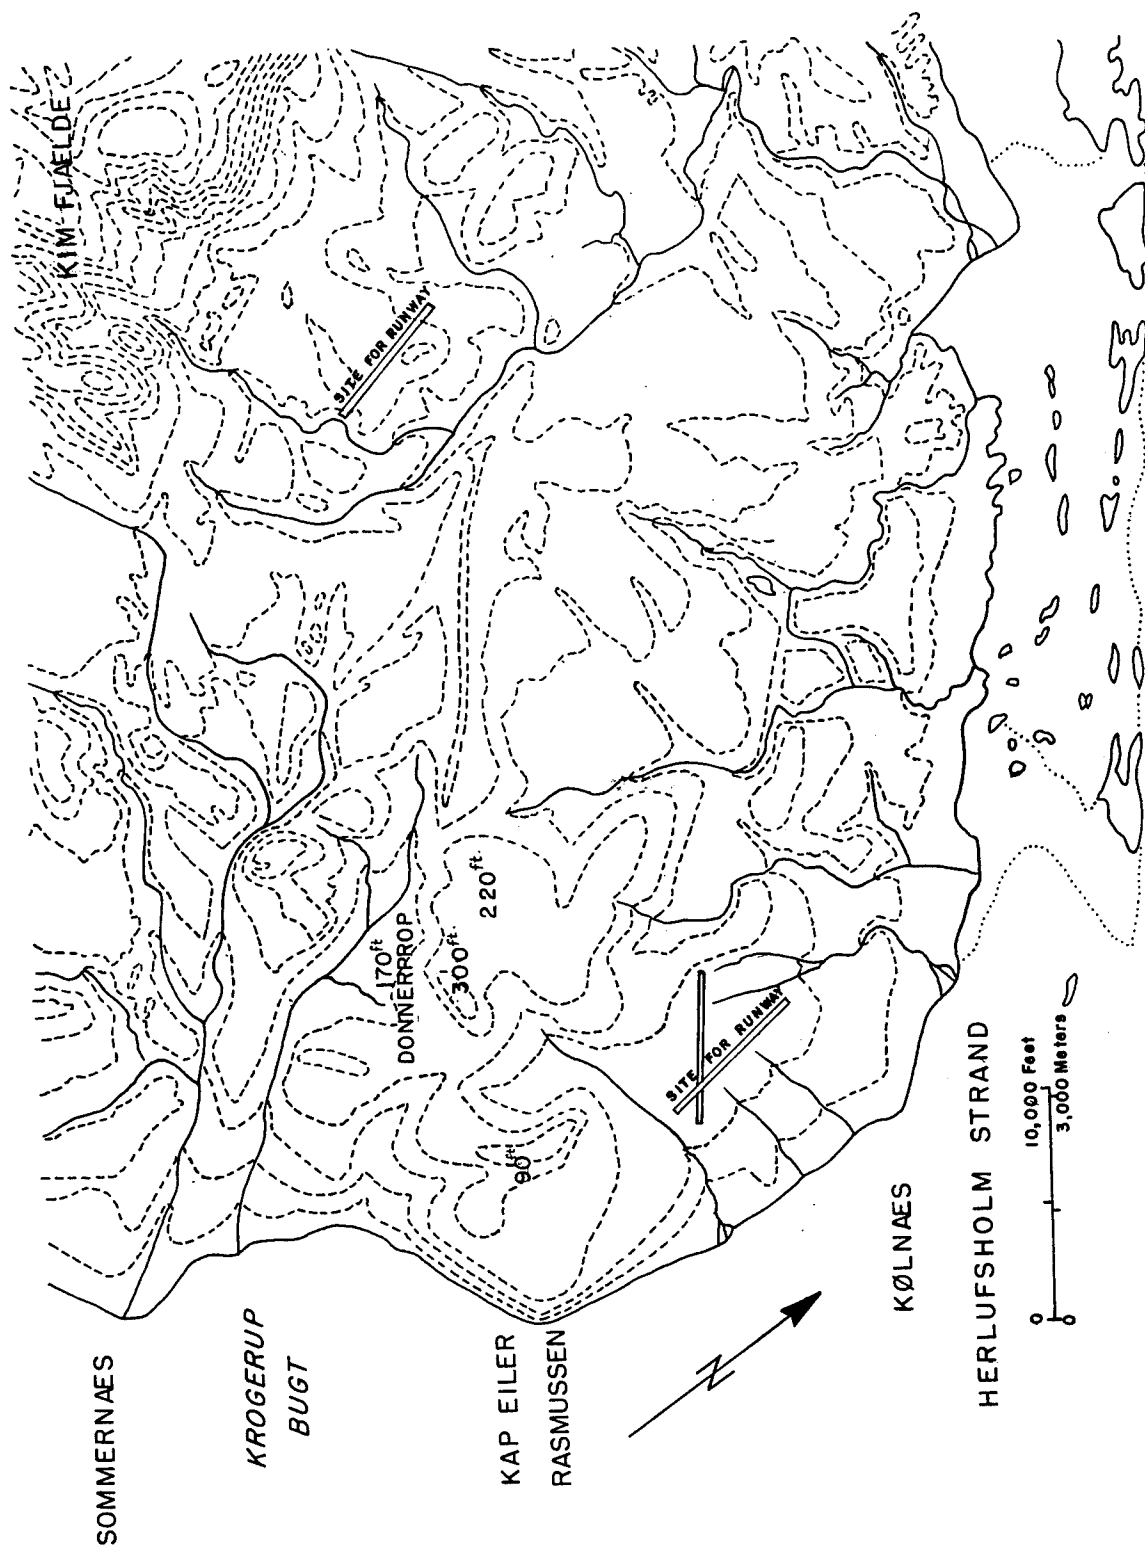
Figure 13. Map of sites at Herlufsholm Strand.

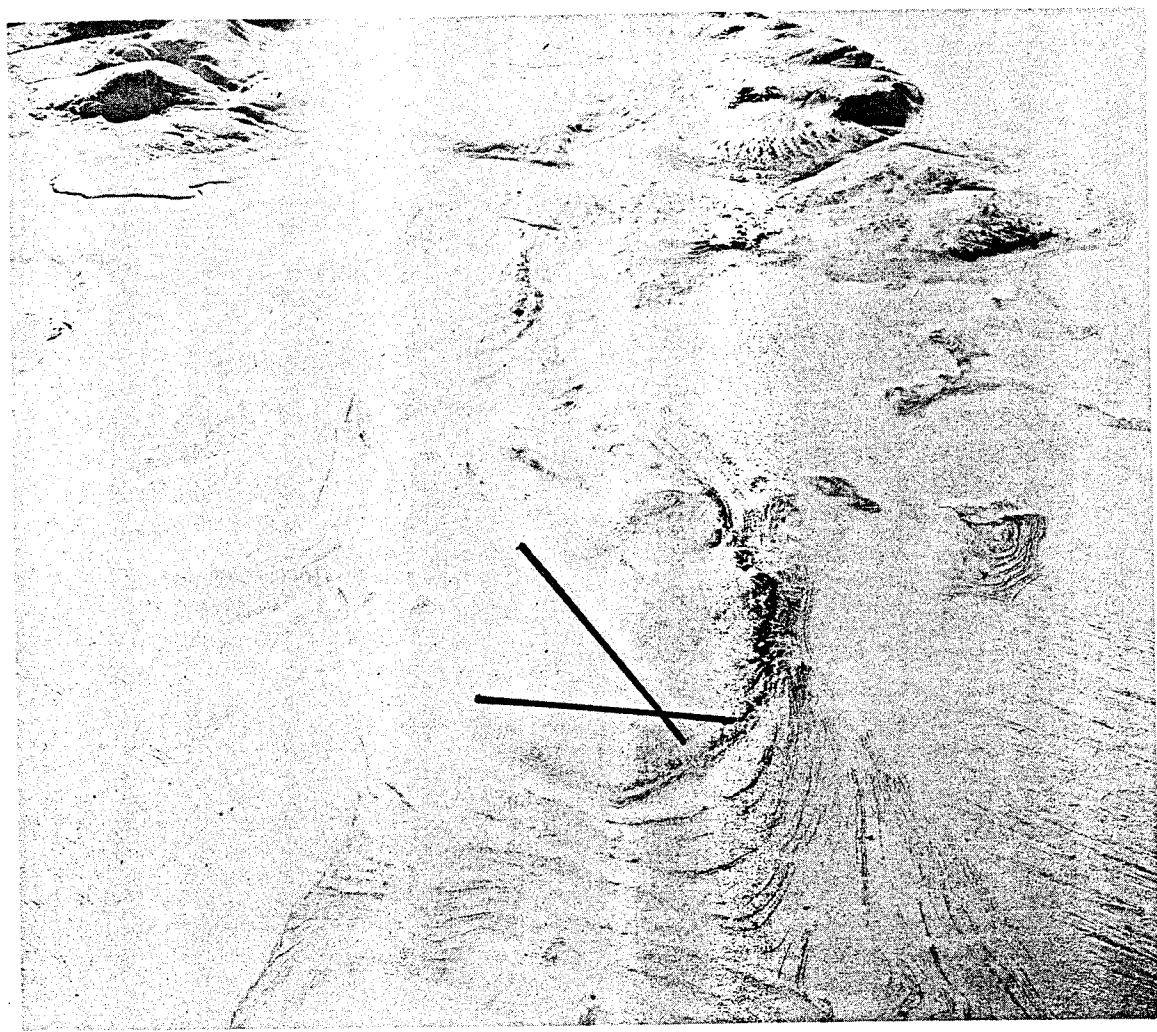
Figure 14. Kap Wyckoff, view west.

Location -- At Kap Wyckoff, Peary Land. $82^{\circ}54'N \times 24^{\circ}00'00''W$ (Fig. 14).

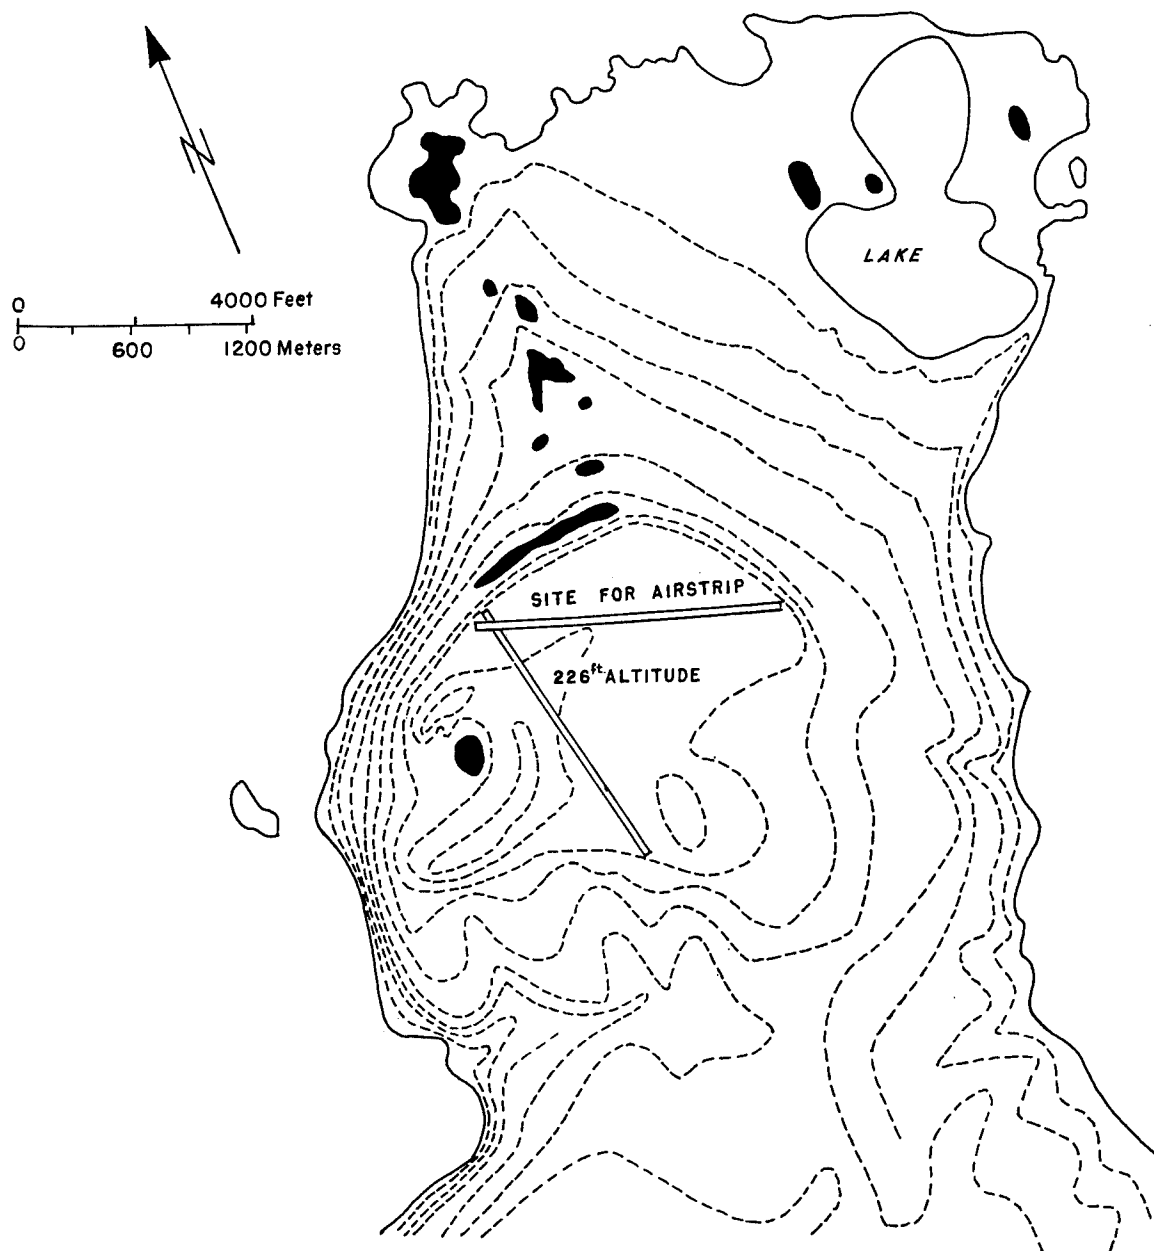
Figure 15. Map of Kap Wyckoff site.

Dimensions and orientation -- Two runways are possible, one oriented $N10^{\circ}W$ with 5100 ft (1554 m) length; the other oriented $N80^{\circ}W$ with 5400 ft (1649 m) length (Fig. 15).

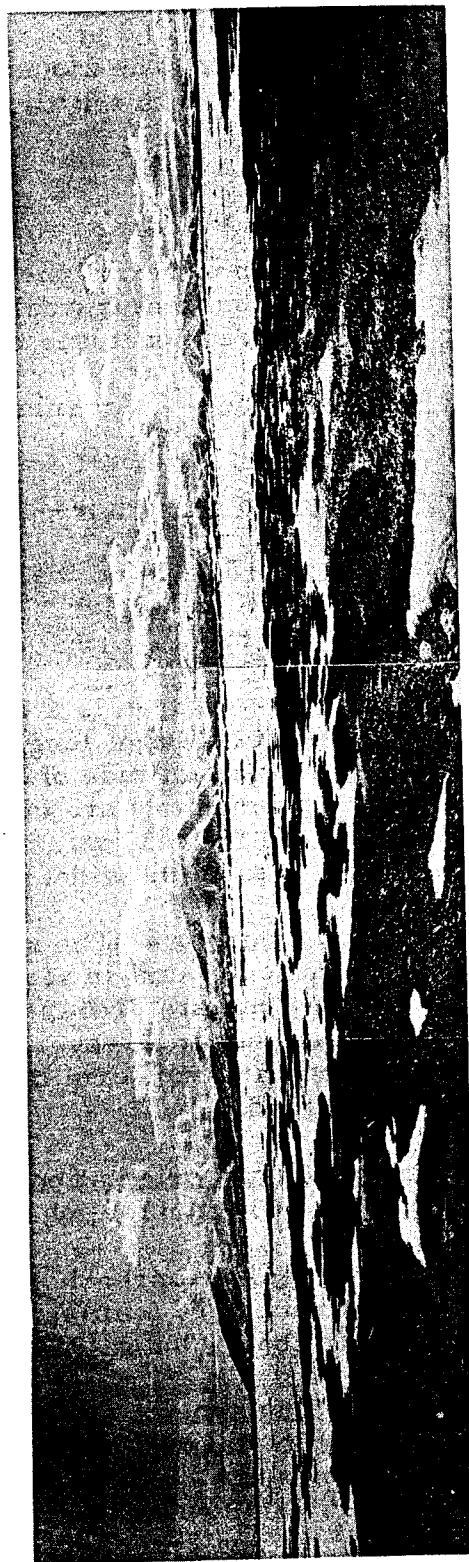
Figure 17. Skagen site, view southwest, 5 July 1960.

Landform -- Skagen is a rounded promontory, 4500 ft (1371 m) wide and 7500 ft (2286 m) long, extending eastwards into the Arctic Ocean. The summit, at an altitude of 80 ft (24 m), is flat (Fig. 17) while the sides of the promontory are cut by two prominent raised beaches at 40 ft (12 m) and 55 ft (17 m). The beaches are in the form of benches 30 to 200 ft (9 to 60 m) wide.

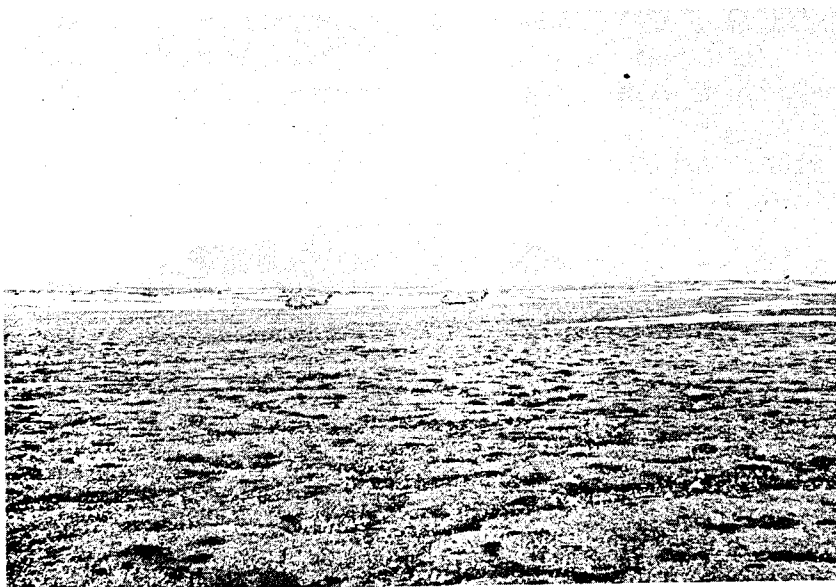
Landform -- The site is on a broad river terrace about 7 ft (2 m) above the Frihed-Radet Elv. The terrace is 3600 ft (1100 m) long northwest-southeast and 2000 ft (610 m) wide northeast-southwest. It is 155 ft (47 m) above sea level. On the northeast and east the site is bounded by morainal ridges rising to 215 ft (65 m); to the northwest the terrace grades into the wide outwash plain that forms the north side of Peary Land. The surface of the terrace is locally pitted with shallow frost depressions as much as 24 inches (60 cm) in diameter and 6 inches (15 cm) in depth (Fig. 19).

Figure 19. Kap Ole Chiewitz site, view WNW,
6 July 1960.

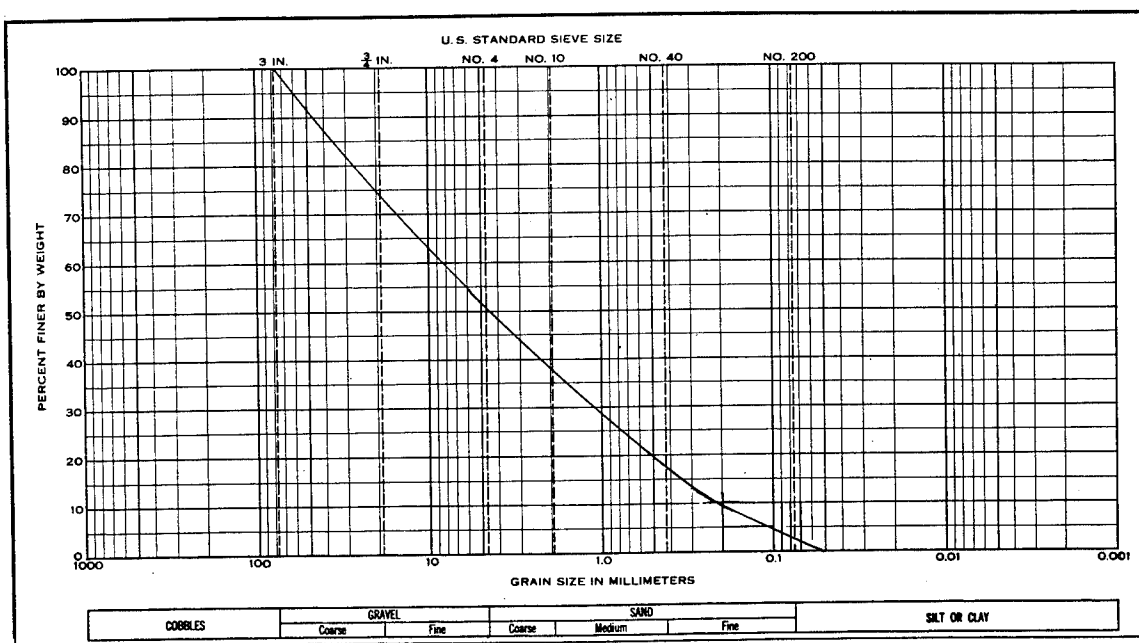
GRADATION CURVE—GRAVEL
KAP OLE CHIEWITZ SITE

Figure 20. Kap Ole Chiewitz site, gradation curve, gravel.

Soil and drainage -- The soil along the site for a runway is densely-packed gravel in a matrix of silty sand. The gravel is composed of pebbles as much as 2 inches (5 cm) in size (Fig. 20). Drainage is good.

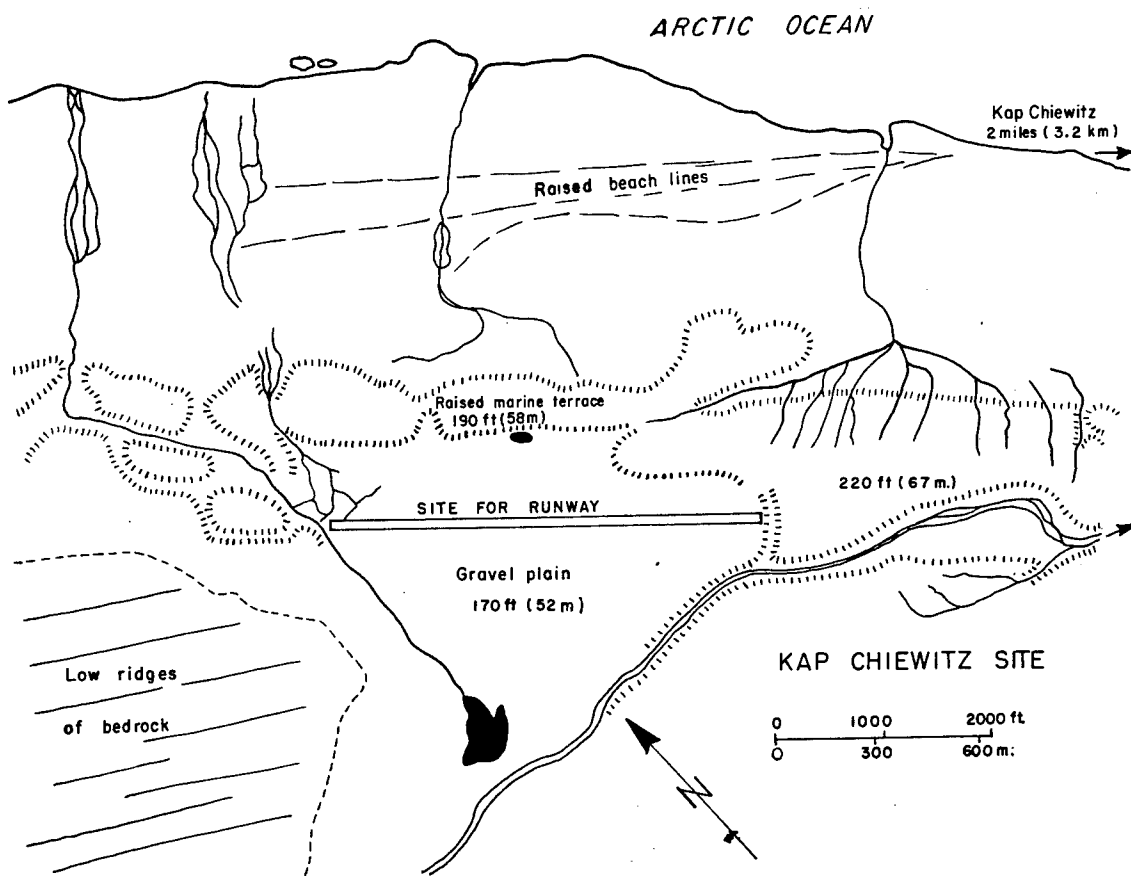
Figure 21. Map of Kap Ole Chiewitz site.

Dimensions and orientation -- The best runway orientation is N60°W, with a length of 3600 ft (1100 m) (Fig. 21).

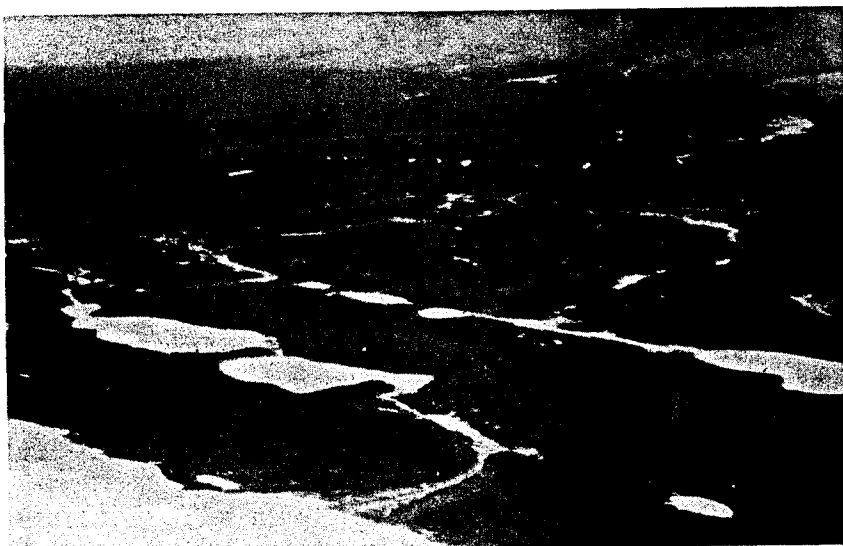
Figure 22. Air view looking SW over Bliss Bugt site, 19 August 1956.

Location -- On the northeast corner of Bliss Bugt, 2 miles (3 km) east of Kap J. P. Koch (Figs. 22 and 23).

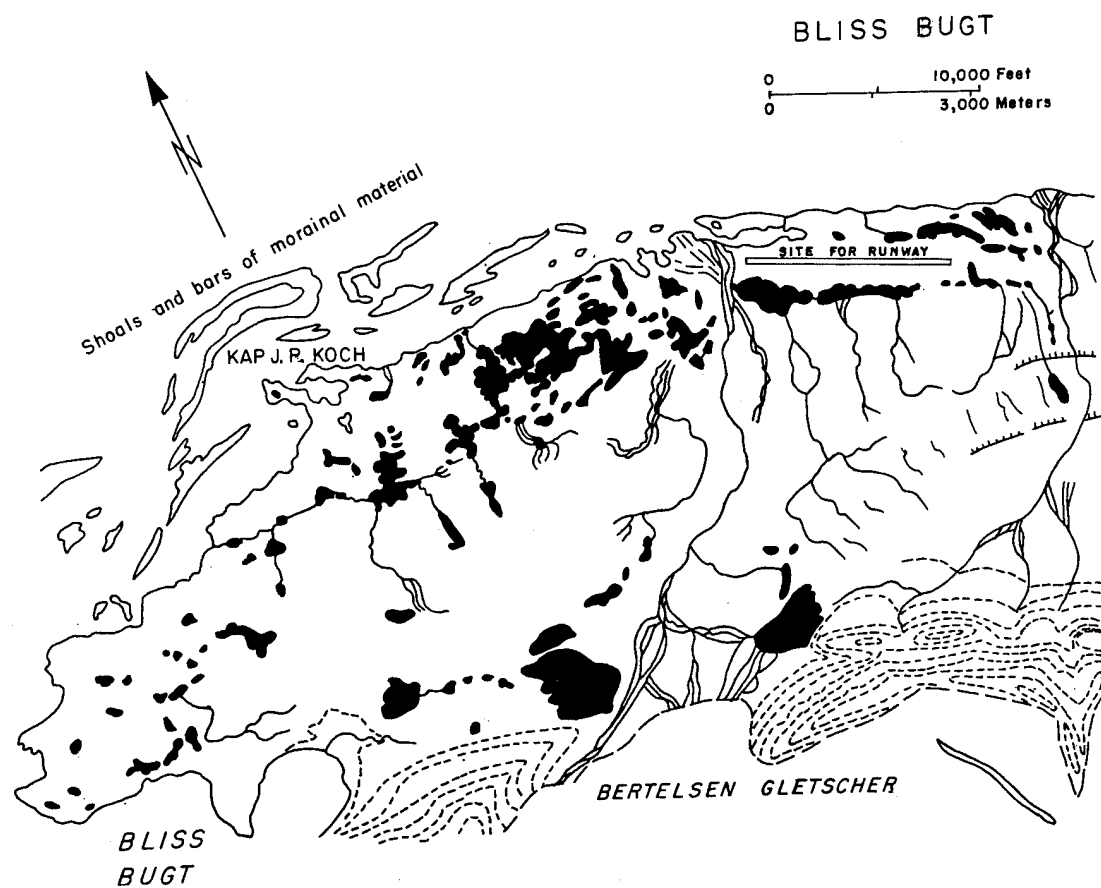
Figure 23. Map of Bliss Bugt site.

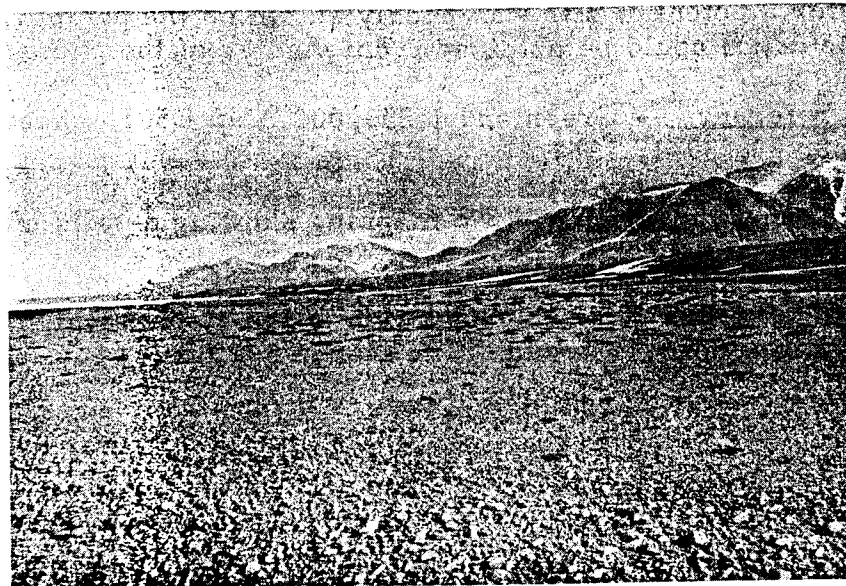
Figure 24. Kap Morris Jesup site, view south-east, 6 July 1960.

Landform -- Kap Morris Jesup is on a broad fan-shaped delta about 2400 ft (731 m) north-south and 12,000 ft (3657 m) east-west. On the south side of the delta are a series of raised beaches cut into two parts by the north-flowing stream that enters the Arctic Ocean at Kap Morris Jesup (Fig. 24).

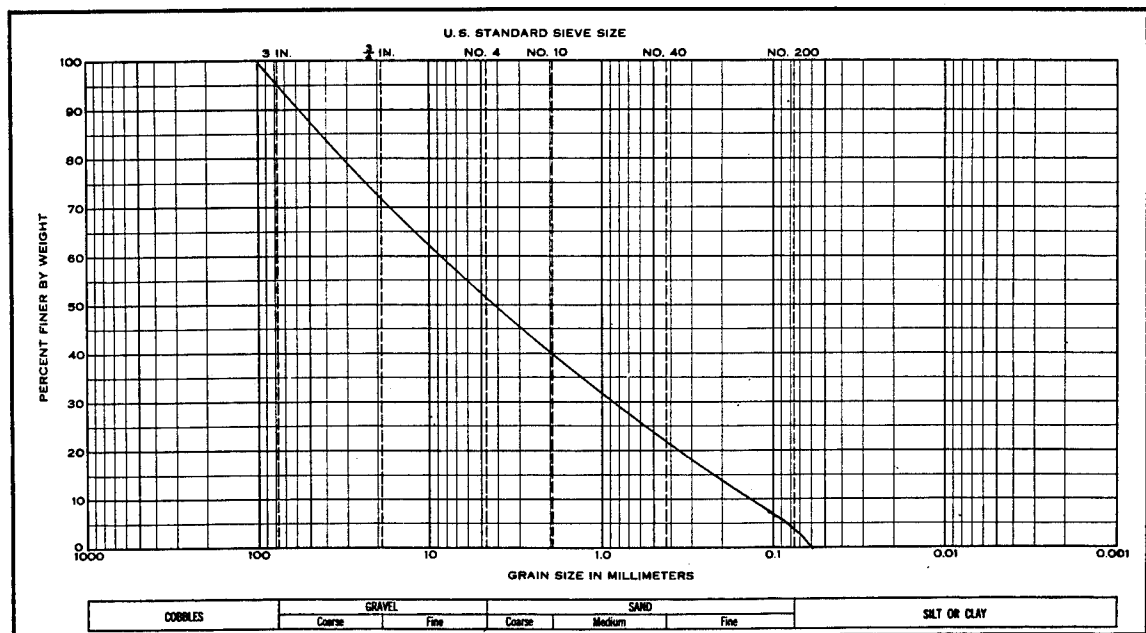
GRADATION CURVE — GRAVEL
KAP MORRIS JESUP SITE

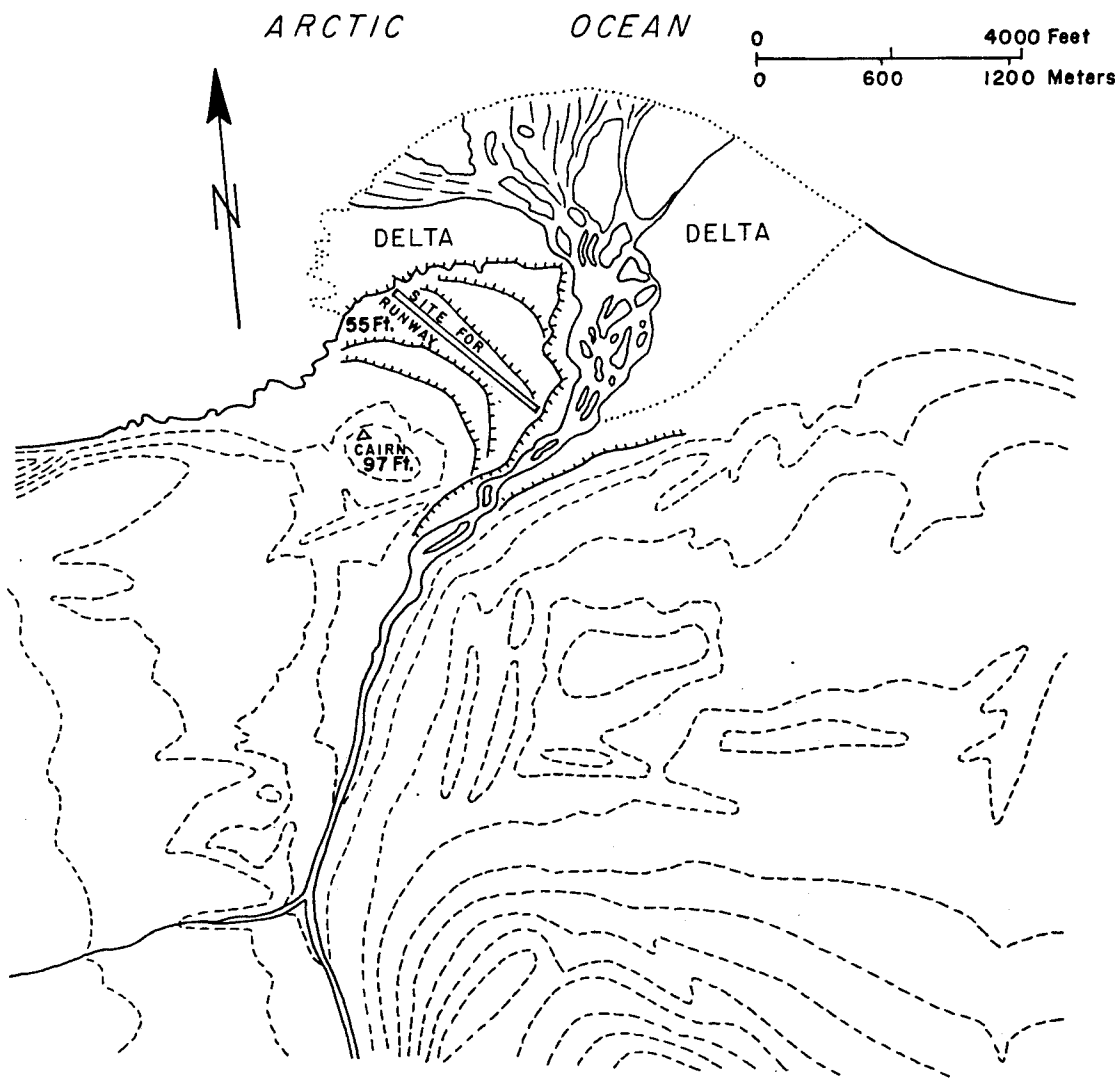
Figure 26. Map of Kap Morris Jesup site.
